**Investigative Summary Report**  
**Rapidan Service Authority Objectionable Odor Event**  
**August 21 – August 27, 2024**

**Report Issue Date: September 25, 2024**

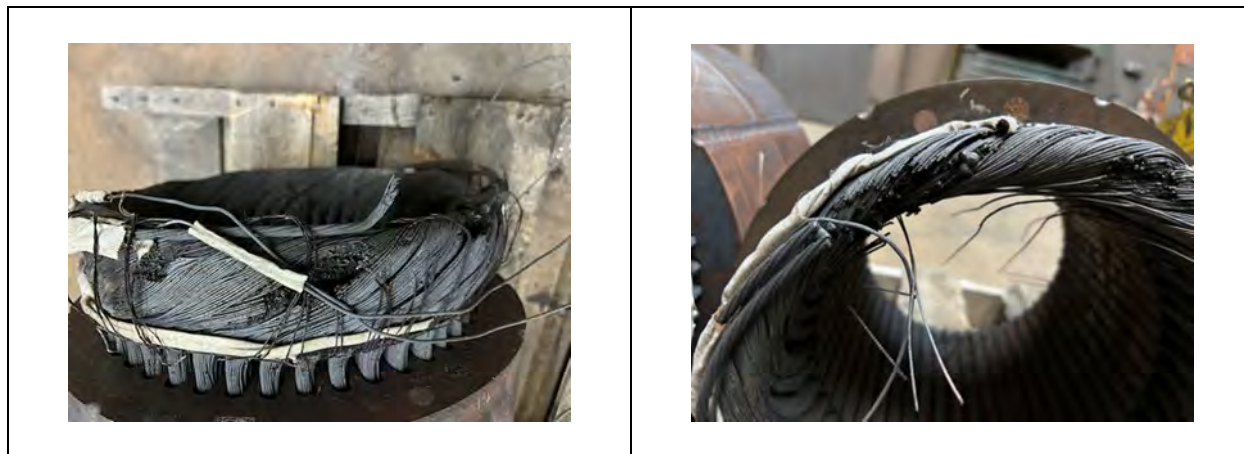
The first intake pump failed on August 20, the day before customers started to report the objectionable odor. ODW and DEQ staff interviewed the pump mechanic who repaired all three intake pumps on September 6. The mechanic stated that he has worked as a pump mechanic for 40 years and had never witnessed such a catastrophic failure before. He stated that two to three gallons of mineral oil were lost. He provided pictures of the internal stator of the pump, which

showed that internal components were scorched, burned, or heated. Pictures of the stator show black and gray wiring from wiring being heated.

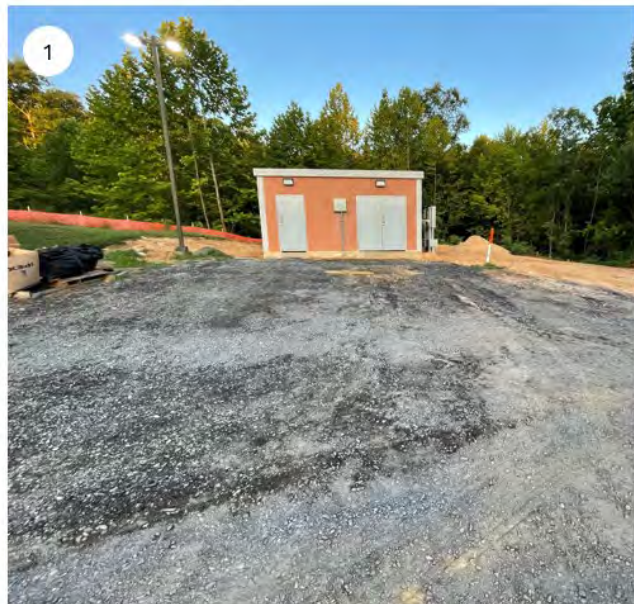
New concrete pad and building for electrical service to wet wells

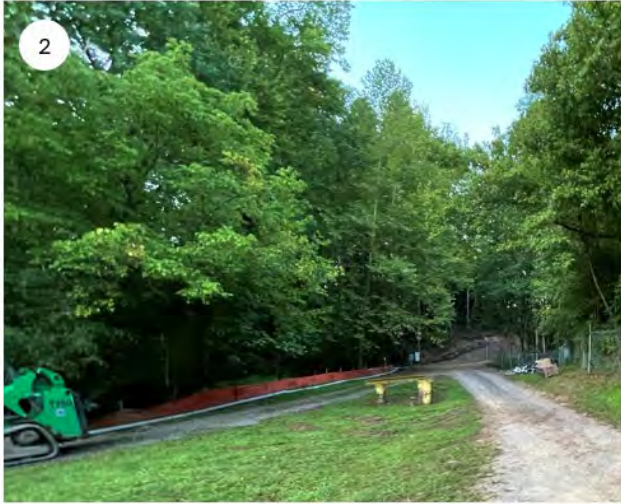
Conduit for new electrical service to wet wells

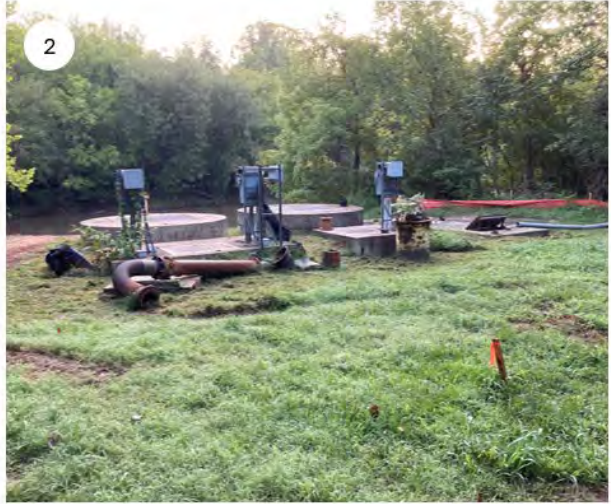
Wet wells

- The “WD-40” odor persists in those wet well chambers. During ODW’s inspection, staff observed a “metallic” appearance as a wall coating, which staff thought was most likely the food grade mineral oil. ODW asked RSA to remediate and remove the mineral oil and odor in the sediment and on surfaces. ODW provided remediation contractor contact information to RSA.

- ODW staff inspected the raw water intake wet wells and observed residual odor and what looked to be mineral oil residue coating some of the walls and equipment surfaces in the well. ODW requested the wells be cleaned out prior to being returned to service and provided a contractor recommendation received by DEQ for the work which will require confined space certification.

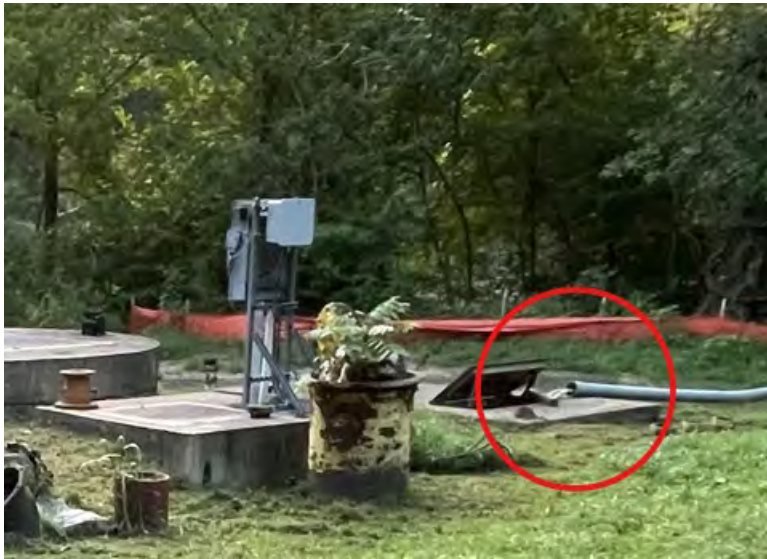
- RSA informed ODW in a meeting that it had determined that the temporary wiring serving the pumps was undersized, starving the pumps for current, and that this was the cause of the pump failures. RSA also advised that the general contractor has worked with the project engineer on the design for an upgrade of the temporary wiring, and an electrical contractor will be used for the work with the work checked and inspected by an independent electrical contractor who is very familiar with large construction projects.

Temporary wiring to raw water pumps
